# Manhole Inspection Summary

Manhole # S29EE2016MH

**Location** Address: **5704 STONY RUN DR**

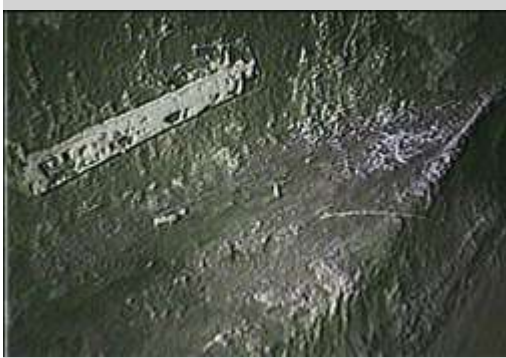
Defect

Infiltration: ☐ None ☐ Joint ☐ Cracks ☒ **Mortar** ☐ Roots ☒ **Wall**

Barrel infiltration.

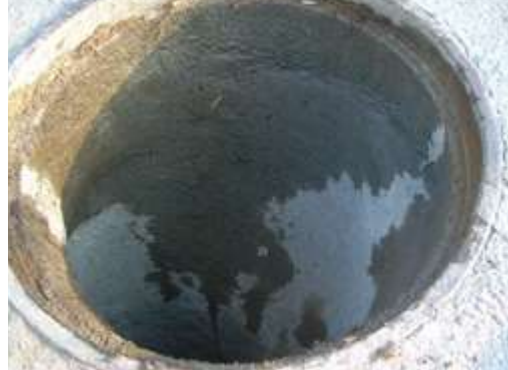
Defect

**Frame** Offset: **12** (in.) Condition: ☐ Sound ☐ Cracked ☒ **Leaks**

Infiltration: ☐ None ☒ **Joint** ☐ Cracks ☐ Mortar ☐ Roots ☒ **Wall**

Frame leaks. Adjustment infiltration.

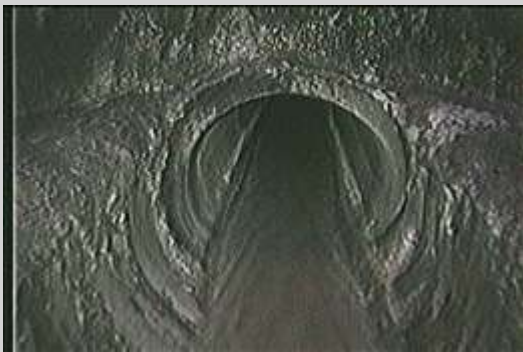
### 15 in. Circular Gravity Sewer Pipe Out @ 12 O'Clock

Infiltration: **Evidence** Pipe Seal Cond: **Unknown**
